PART I. Loch Erin Improvement Study and Management Plan Lenawee County, Michigan

Provided for: Loch Erin Property Owners Association (LEPOA) Board

**Prepared by: Restorative Lake Sciences
Jennifer L. Jermalowicz-Jones, PhD
Water Resources Director
18406 West Spring Lake Road
Spring Lake, Michigan 49456
www.restorativelakesciences.com**

February 2020

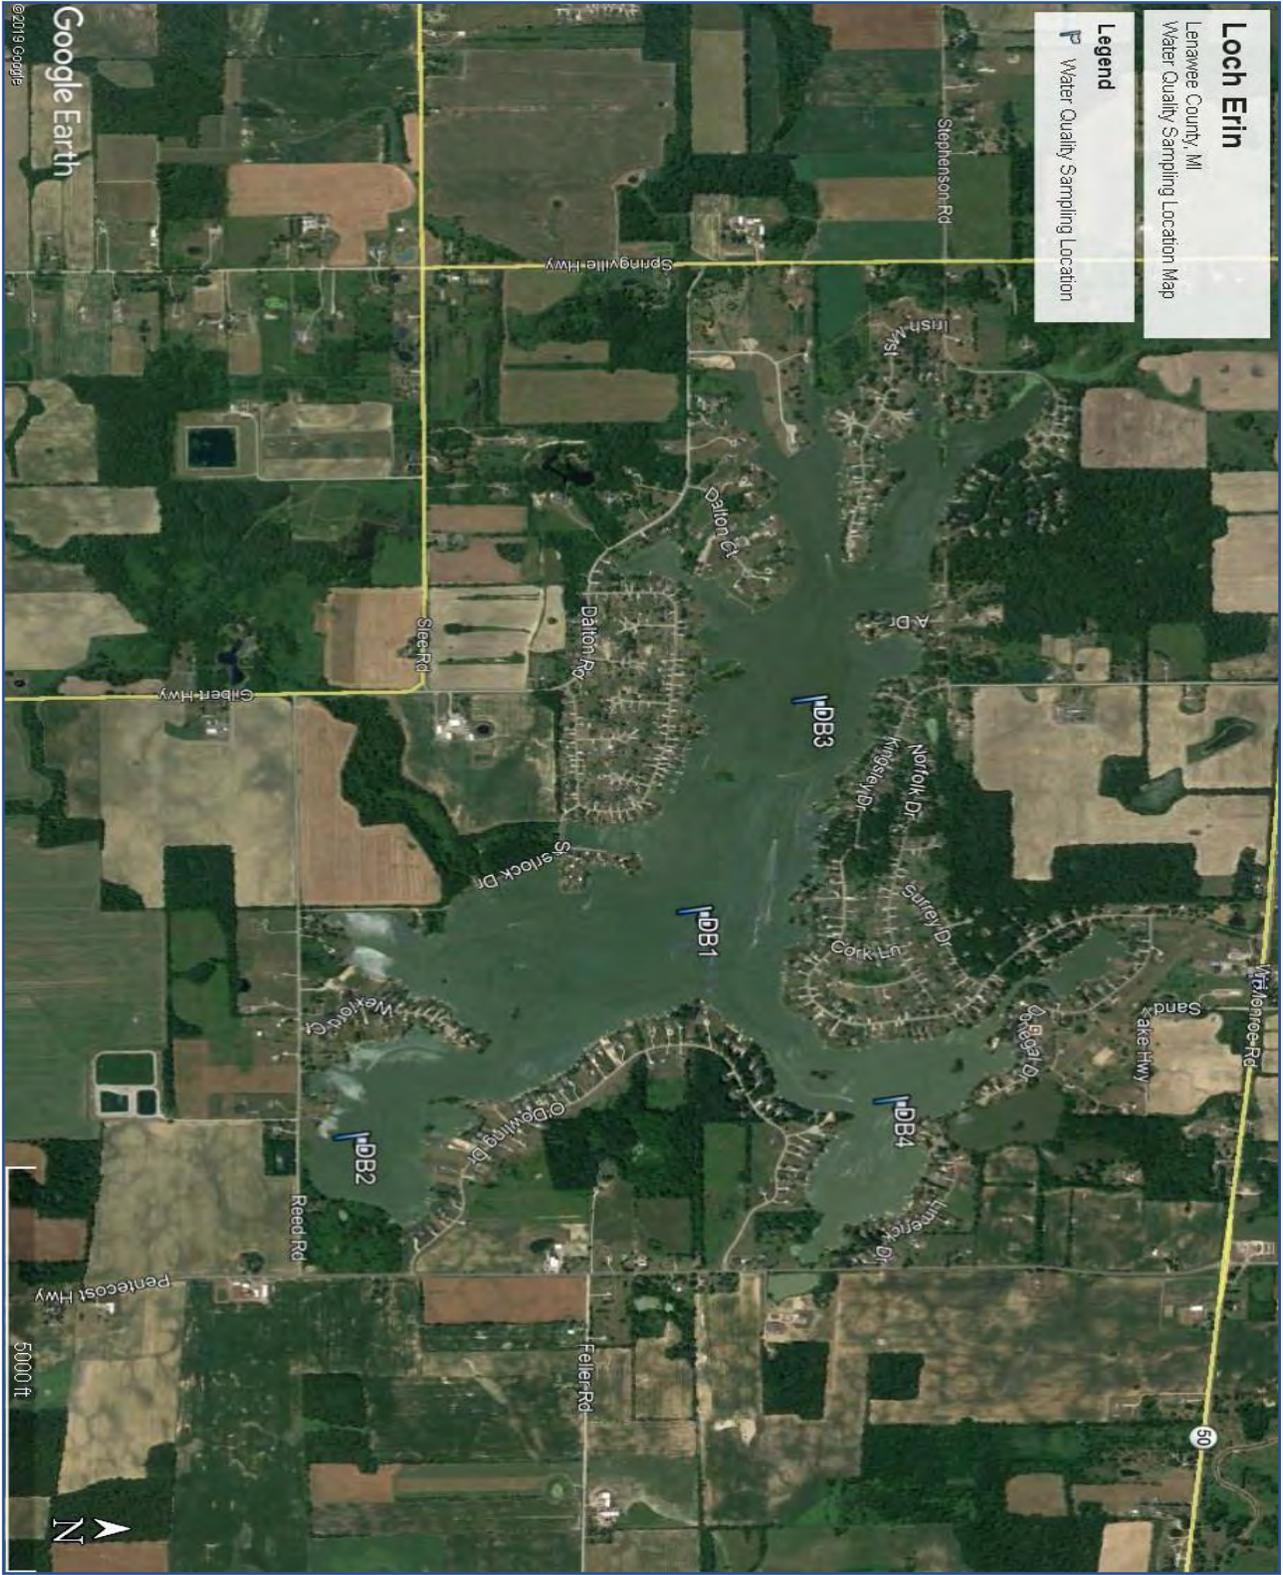
Figure 5. Locations for water quality sampling of the deep basins in Loch Erin (August 15, 2019).

Parameters such as dissolved oxygen (in mg/L), water temperature (in °C), specific conductivity (mS/cm), turbidity (NTU's), total dissolved solids (mg/L), total suspended solids (mg/L), pH (S.U.), total phosphorus and ortho-phosphorus (also known as soluble reactive phosphorus or SRP measured in mg/L), total Kjeldahl nitrogen and total inorganic nitrogen (in mg/L), chlorophyll-a (in µg/L), and Secchi transparency (in feet) are parameters that respond to changes in water quality and consequently serve as indicators of change. The deep basin results for all abiotic and biotic water quality parameters are discussed below and are presented in Tables 4-12. A map showing the sampling locations for all water quality samples is shown below in Figure 5. All water samples and readings were collected at the 4 deepest basins on August 15, 2019 with the use of a 3.2-Liter Van Dorn horizontal water sampler and calibrated Eureka Manta II® multi-meter probe with parameter electrodes, respectively. All samples with the exception of chlorophyll-a were taken to a NELAC-certified laboratory for analysis.

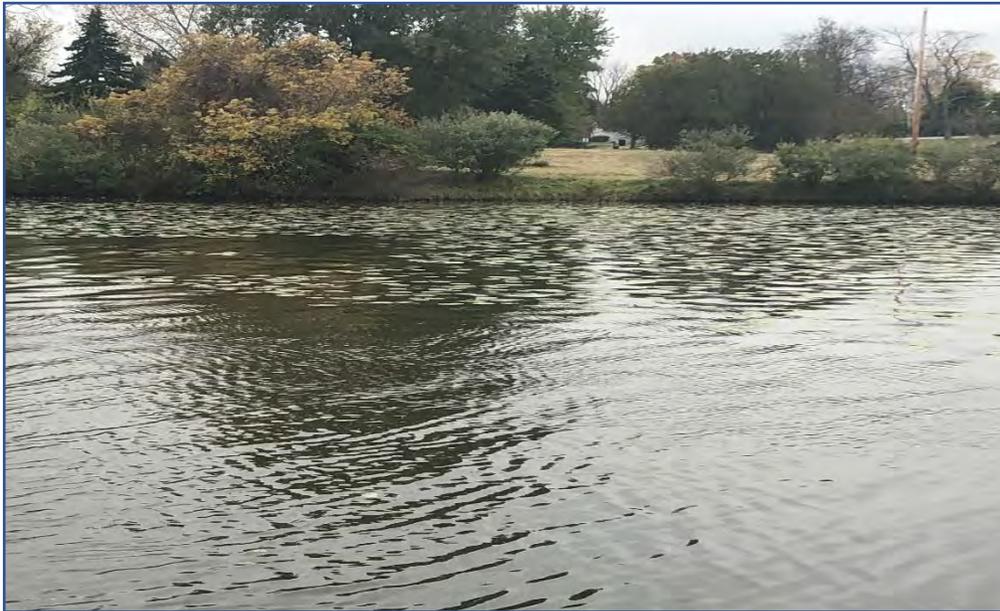
Figure 9. Abundant lily pads near the northwest region of the lake.

The dominant native aquatic plants in the lake basin of the lake included the Chara and White waterlily (Figure 9). The lily pads cover many shallow areas in the lake but are essential for fish cover given the low abundance of rooted submersed aquatic plant species. The relative abundance of rooted aquatic plants (relative to non-rooted plants) in the lake suggests that the sediments are the primary source of nutrients (relative to the water column), since these plants obtain most of their nutrition from the sediments. The emergent plants, such as Arrowhead (Figure 10) are critical for shoreline stabilization as well as for wildlife and fish spawning habitat. Photos of all native aquatic plants are shown below in Figures 11-17.

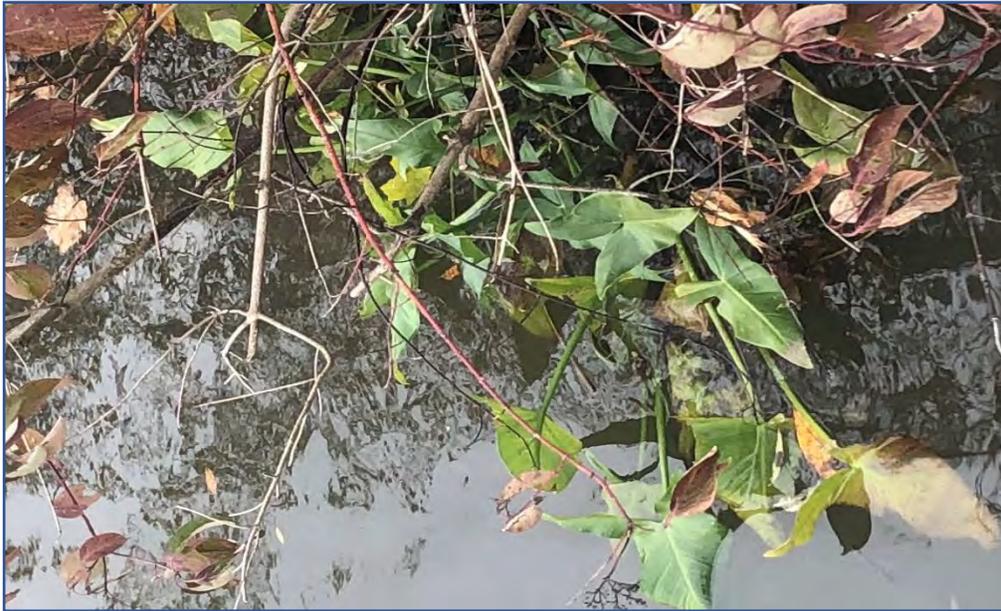
Figure 10. Abundant emergent Arrowhead near the northwest of the lake.

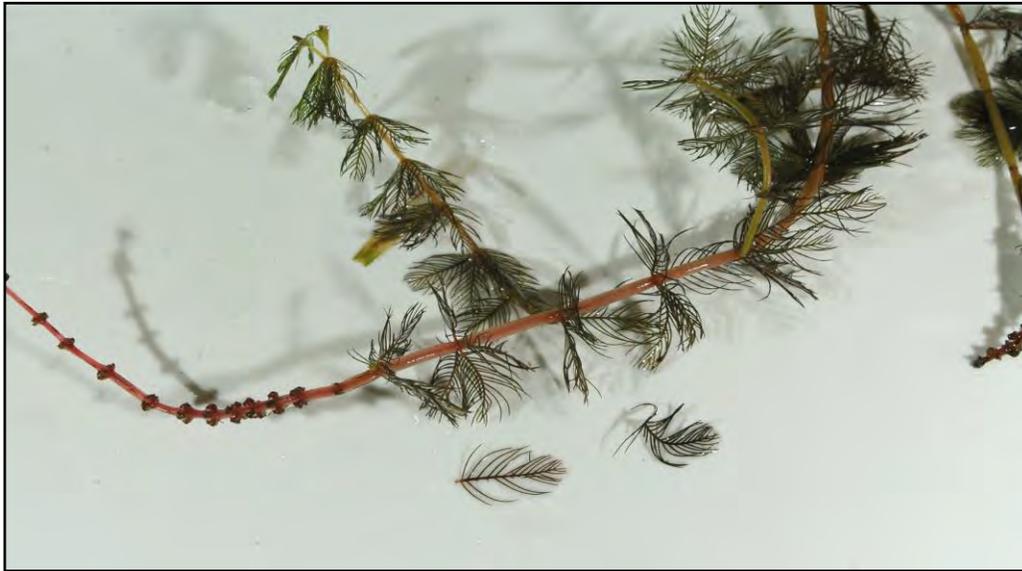
Figure 18. Hybrid Eurasian Watermilfoil plant with seed head and fragments (©RLS).

Eurasian Watermilfoil was found in a few locations throughout the lake and this distribution likely varies among years and seasons. Table 15 shows the various invasives found and their relative abundance in the lake and Figure 22 shows the distribution of invasive aquatic plants found in and around Loch Erin on July 11, 2019.

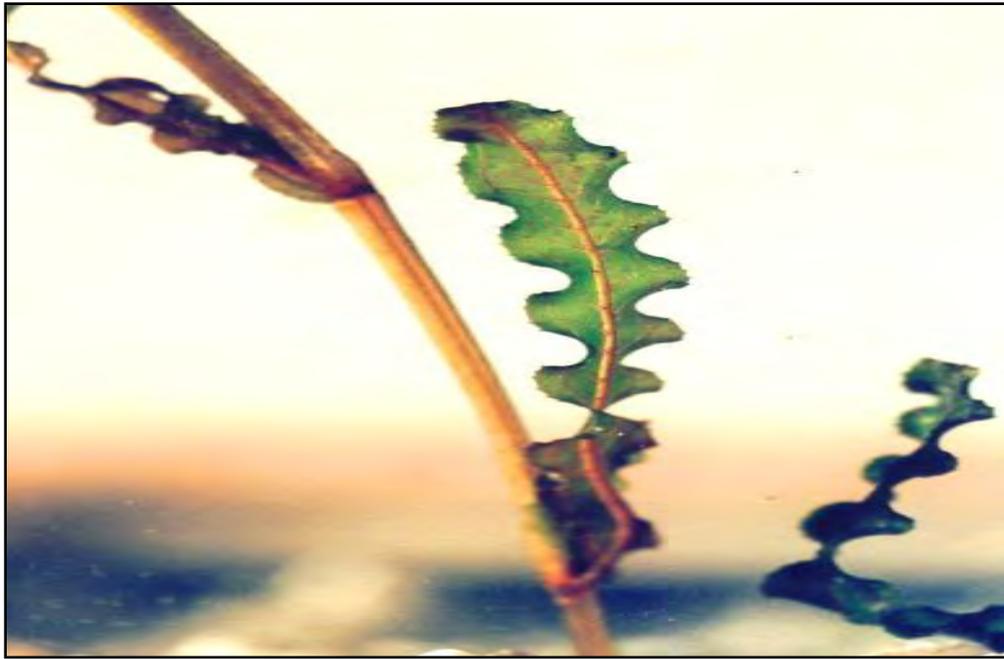
Figure 20. Curly-leaf Pondweed (©RLS).

Curly-leaf Pondweed (*Potamogeton crispus*; Figure 20) is an exotic, submersed, rooted aquatic plant that was introduced into the United States in 1807 but was abundant by the early 1900's. It is easily distinguished from other native pondweeds by its wavy leaf margins. It grows early in the spring and as a result may prevent other favorable native aquatic species from germinating.

The plant reproduces by the formation of fruiting structures called turions. It does not reproduce by fragmentation as invasive watermilfoil does; however, the turions may be deposited in the lake sediment and germinate in following seasons. Curly-leaf Pondweed is a pioneering aquatic plant species and specializes in colonizing disturbed habitats. It is highly invasive in aquatic ecosystems with low biodiversity and unique sediment characteristics. Curly-leaf pondweed was found in a few locations of the lake.

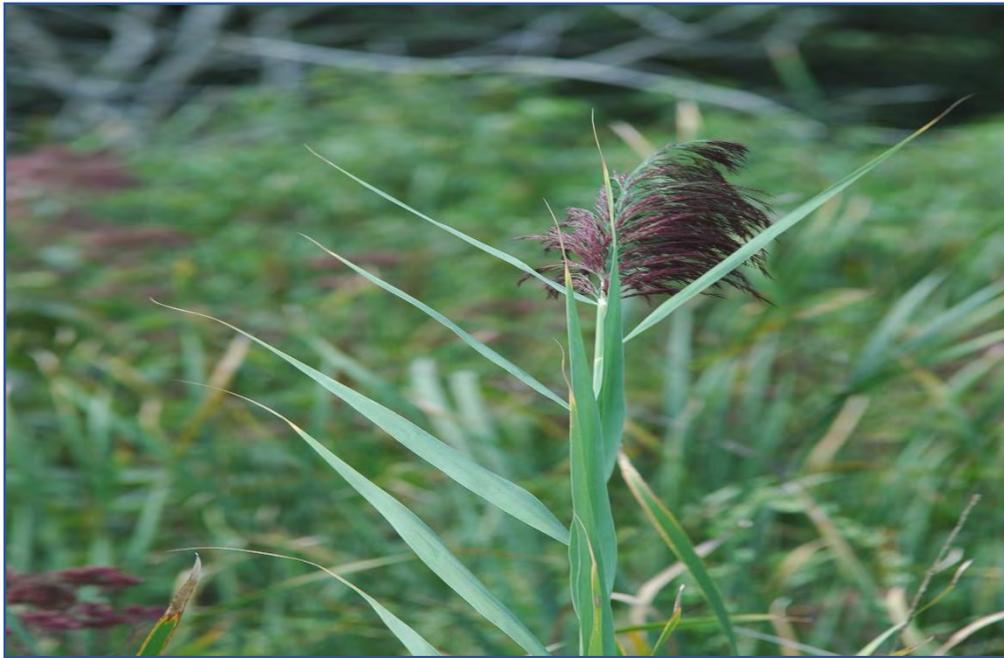
Figure 21. The invasive emergent Phragmites (©RLS).

The Giant Common Reed (*Phragmites australis*; Figure 21) is an imminent threat to the surface area and shallows of the lake since it may grow submersed in water depths of ≥ 2 meters (Herrick and Wolf, 2005), thereby drying up wetland habitat and reducing lake surface area. In addition, large, dense stands of *Phragmites* accumulate sediments, reduce habitat variability, and impede natural water flow (Wang et al., 2006). This plant was found in four locations within the lake basin.

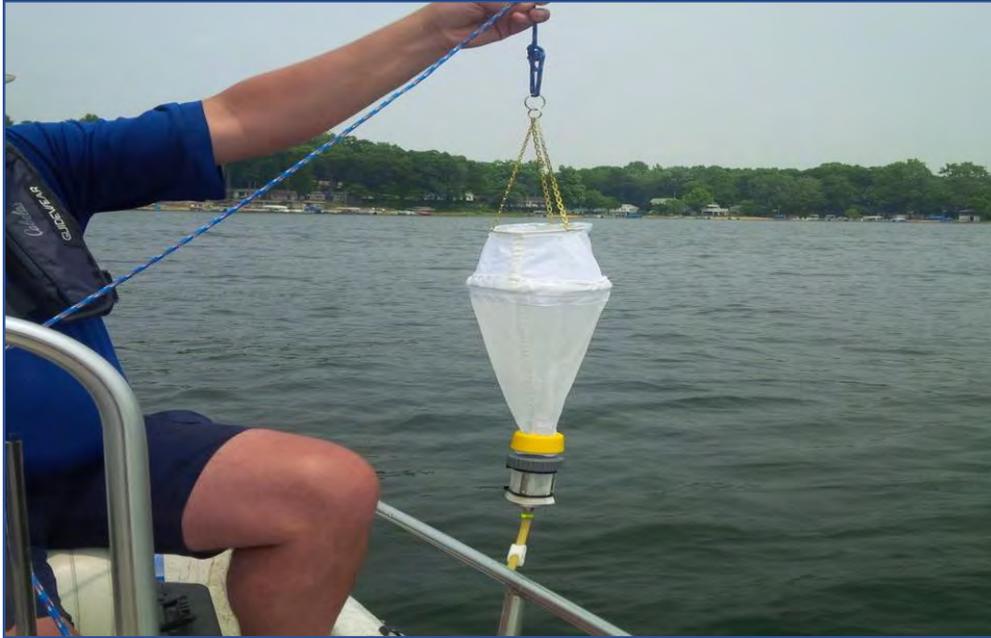
Figure 23. A zooplankton collection tow net (RLS, 2018).

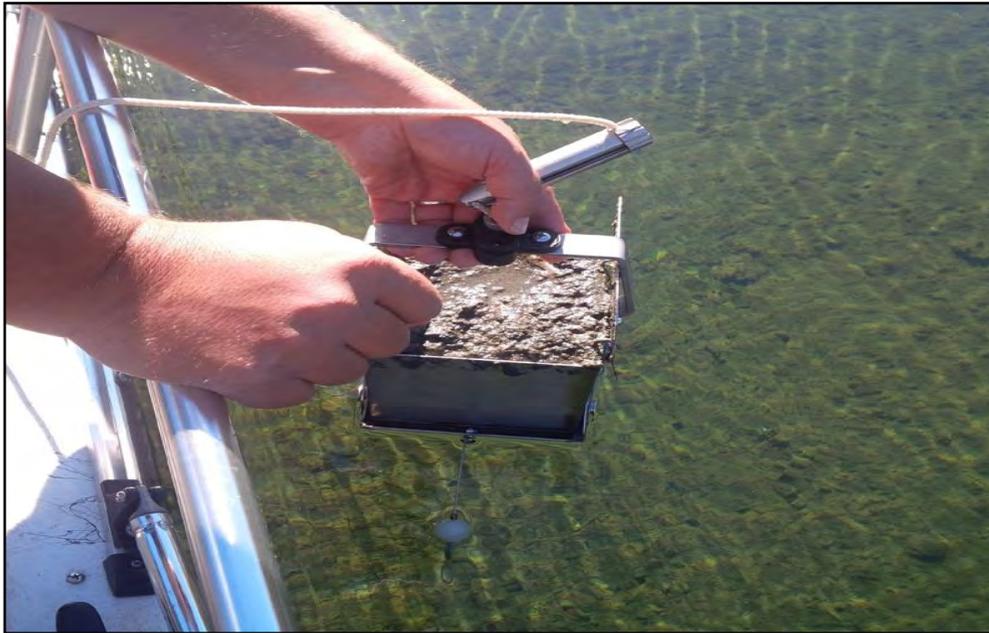
Figure 24. An Ekman hand dredge for sampling lake sediments (RLS, 2018).

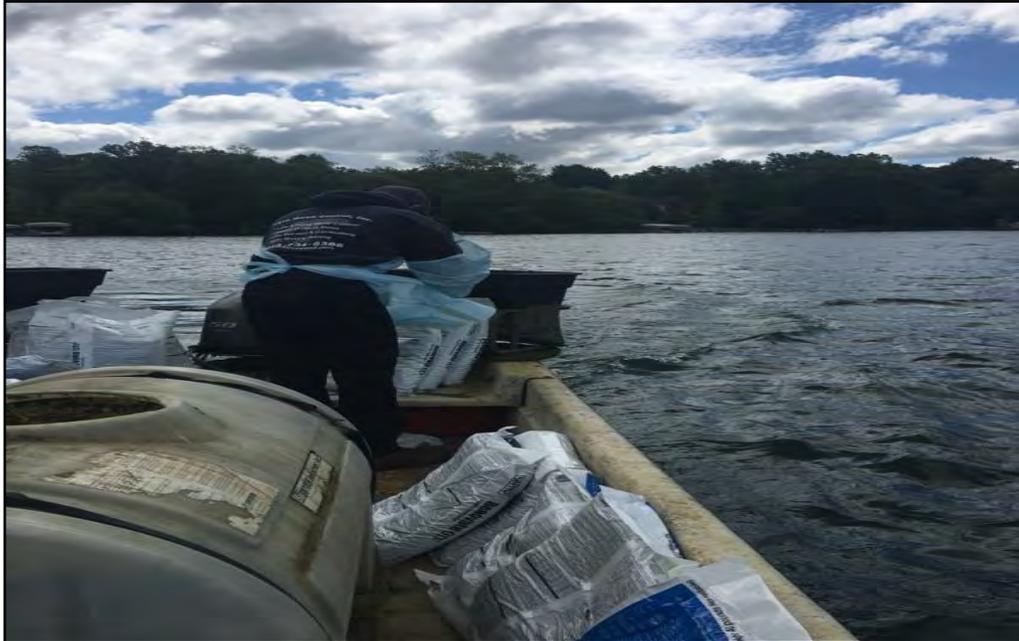
Figure 31. A boat used to apply aquatic herbicides in inland lakes (RLS, 2018).

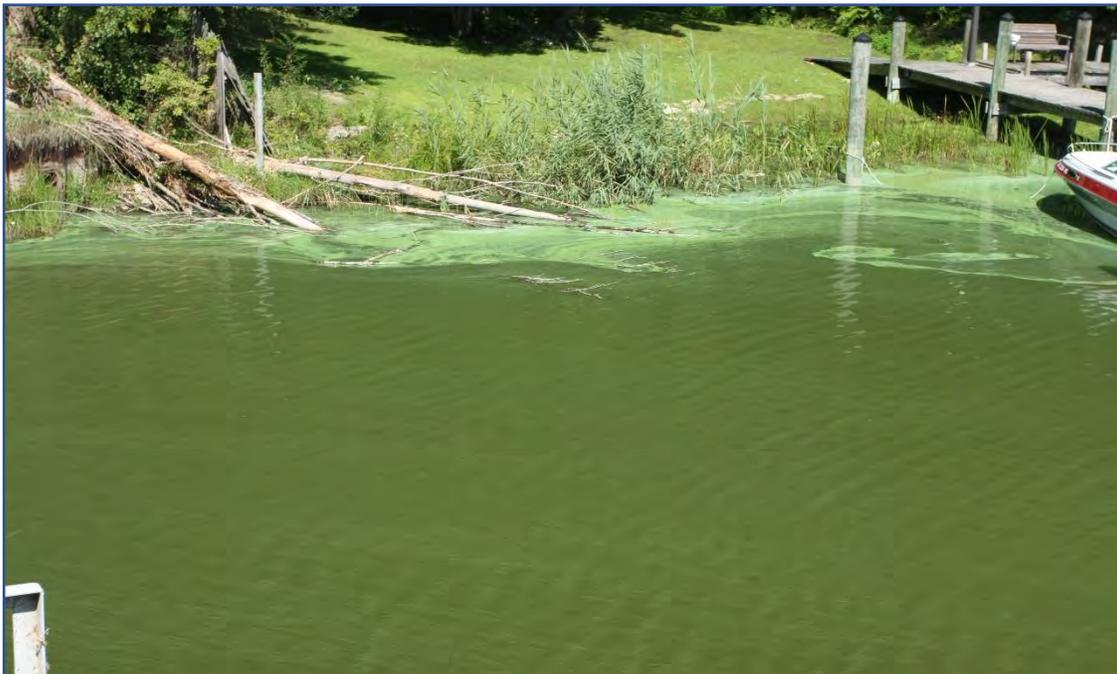
Figure 32. A late season algal bloom on a Michigan inland lake (©RLS).

Algaecides should only be used on green algal blooms since many treatments can exacerbate blue-green algae blooms. The blue-green algae, *Microcystis* sp. was the most prevalent algae in the lake, which is an indicator of poor water quality (Figure 32). *Microcystis* colonies are a few micrometers in diameter and are evenly distributed throughout a gelatinous matrix. Younger colonies are spherical and older ones are more irregularly shaped. There are numerous gas vesicles and the algae can thrive at the surface with minimal photo-degradation (breaking down) by the sun. When the sunlight is excessive, the algae can break

down and release toxins and lower the dissolved oxygen in the water column. The algae are the only type known to fix nitrogen gas into ammonia for growth. *Microcystis* has also been shown to overwinter in lake sediments (Fallon et al., 1981). In addition, it may thrive in a mucilage layer with sediment bacteria that can release phosphorus under anaerobic conditions (Brunberg, 1995). They assume a high volume in the water column (Reynolds, 1984) compared to diatoms and other single-celled green algae. The blue-green algae have been on the planet nearly 2.15 billion years and have assumed strong adaptation mechanisms for survival. In general, calm surface conditions will facilitate enhanced growth of this type of algae since downward transport is reduced. *Microcystis* may also be toxic to zooplankton such as *Daphnia* which was a zooplankton present in Loch Erin and in most lakes (Nizan et al., 1986). Without adequate grazers to reduce algae, especially blue greens, the blue-green population will continue to increase and create negative impacts to water bodies. Filamentous algae will also continue to increase in stagnant areas due to high nutrient levels in the lake. Algaecides are not recommended for algal control in Loch Erin as they often exacerbate growth of blue-green algae.

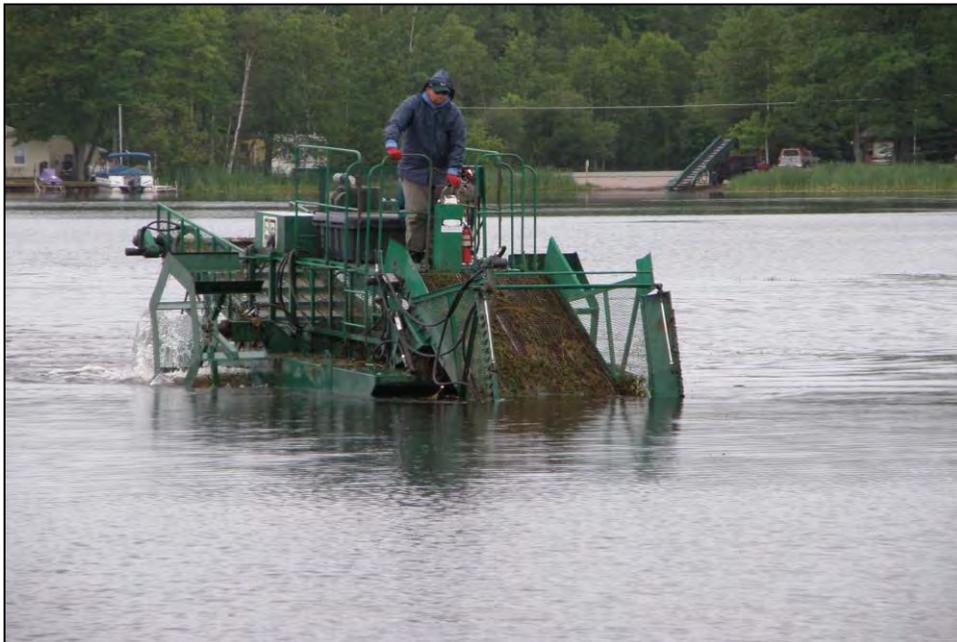
Figure 33. A mechanical harvester used to remove aquatic plants (RLS, 2018).

Mechanical harvesting is usually not recommended for the removal of Eurasian Watermilfoil since the plant may fragment when cut and re-grow on the lake bottom. It may be considered in future years for removal of only dense lily pads in Loch Erin. However, those lily pads are urgently needed for fish cover.

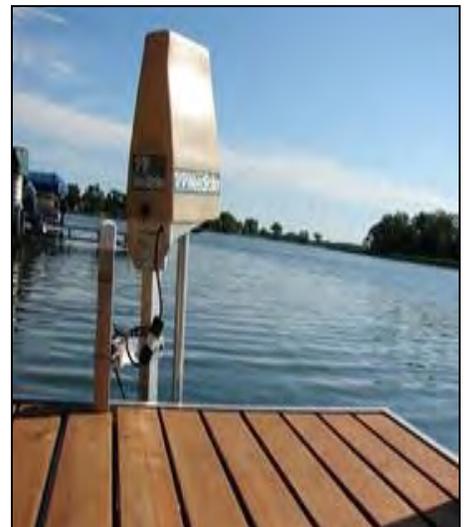
Figure 35. A Weed Roller.

The use of benthic barrier mats (Figure 34) or Weed Rollers (Figure 35) have been used to reduce weed growth in small areas such as in beach areas and around docks. The benthic mats are placed on the lake bottom in early spring prior to the germination of aquatic vegetation. They act to reduce germination of all aquatic plants and lead to a local area free of most aquatic

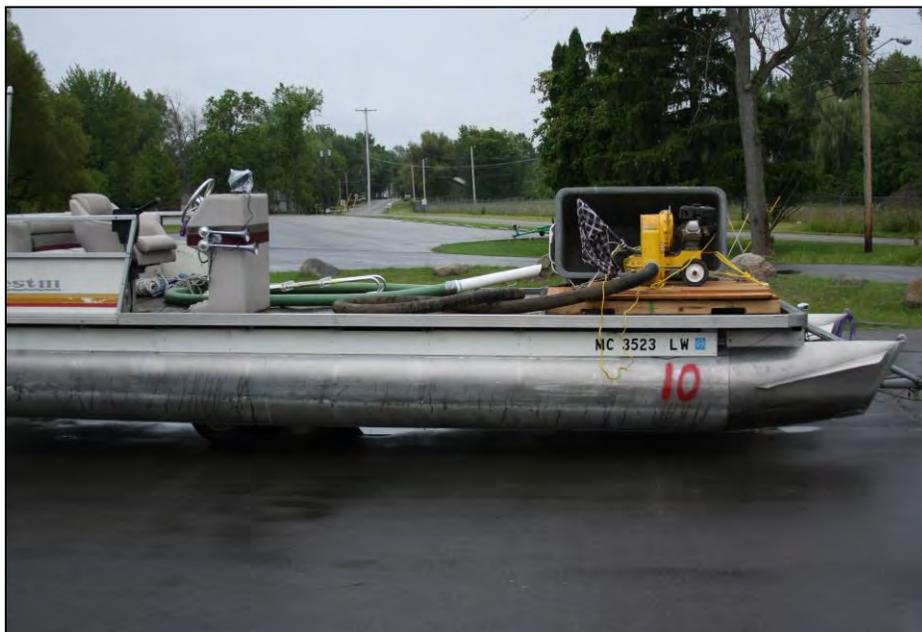
Figure 36. A DASH boat used for aquatic plant removal (RLS, 2018).

Suction harvesting via a Diver Assisted Suction Harvesting (DASH) boat (Figure 36) involves hand removal of individual plants by a SCUBA diver in selected areas of lake bottom with the use of a hand-operated suction hose. Samples are dewatered on land or removed via fabric bags to an offsite location. This method is generally recommended for small (less than 1 acre) spot removal of vegetation since it is costly on a large scale. It may be used in the future to remove small areas of dense growth in shallow areas but is not recommended at this time

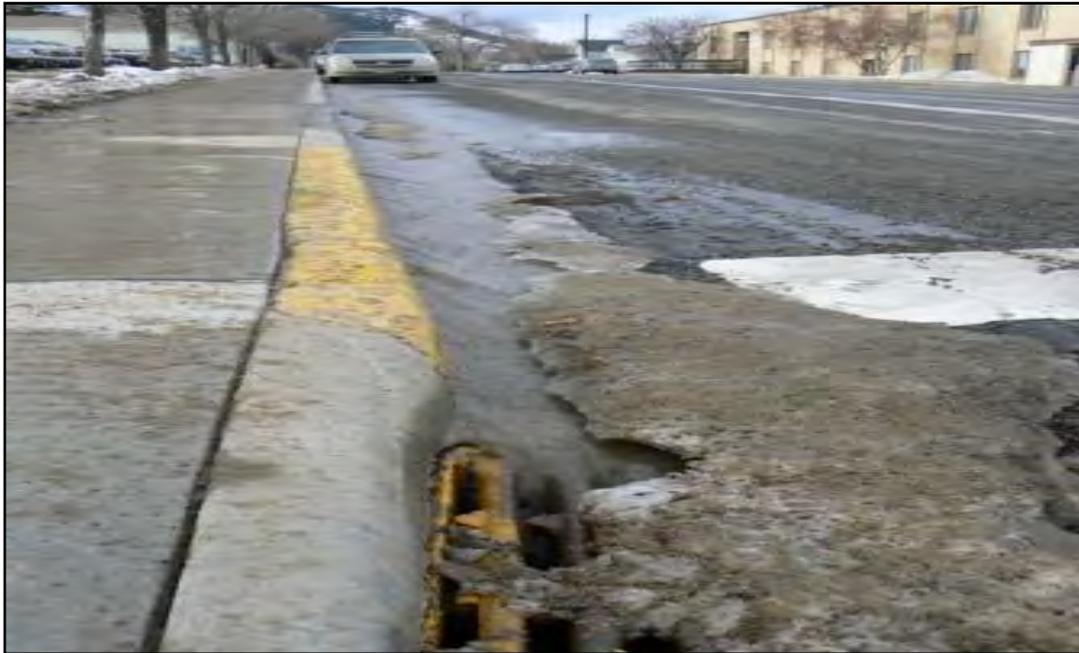
Figure 2. A storm drain emptying a residential street that leads to a lake.

Residential land use activities involve the use of lawn fertilizers on lakefront lawns, the utilization of septic tank systems for treatment of residential sewage, the construction of impervious (impermeable, hard-surfaced) surfaces on lands within the watershed (Figure 1), the burning of leaves near the lakeshore, the dumping of leaves or other pollutants into storm drains, and removal of vegetation from the land and near the water. In addition to residential land use activities, agricultural land practices by vegetable crop and cattle farmers may contribute nutrient loads to lakes and streams through erosion or runoff. All land uses may contribute to the water quality of the lake through the influx of pollutants from non-point sources (NPS) or from point sources. Non-point sources are often diffuse and arise when climatic events carry pollutants from the land into the lake. Point-source pollutants exit from pipes or input devices and empty directly into a lake or watercourse (Figure 2).

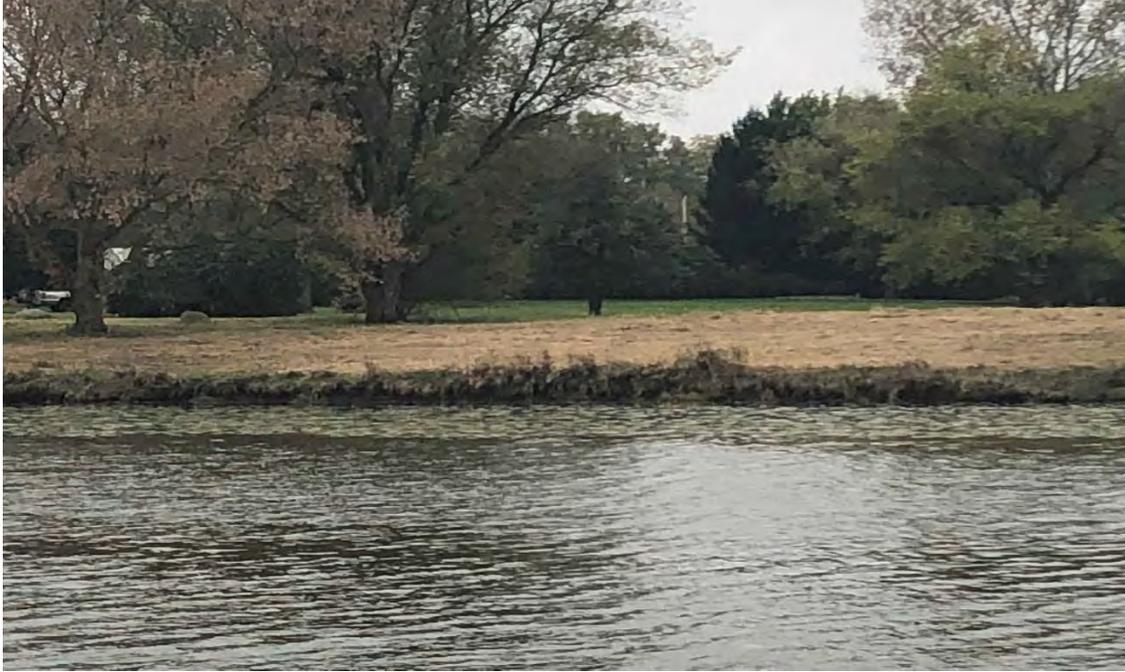
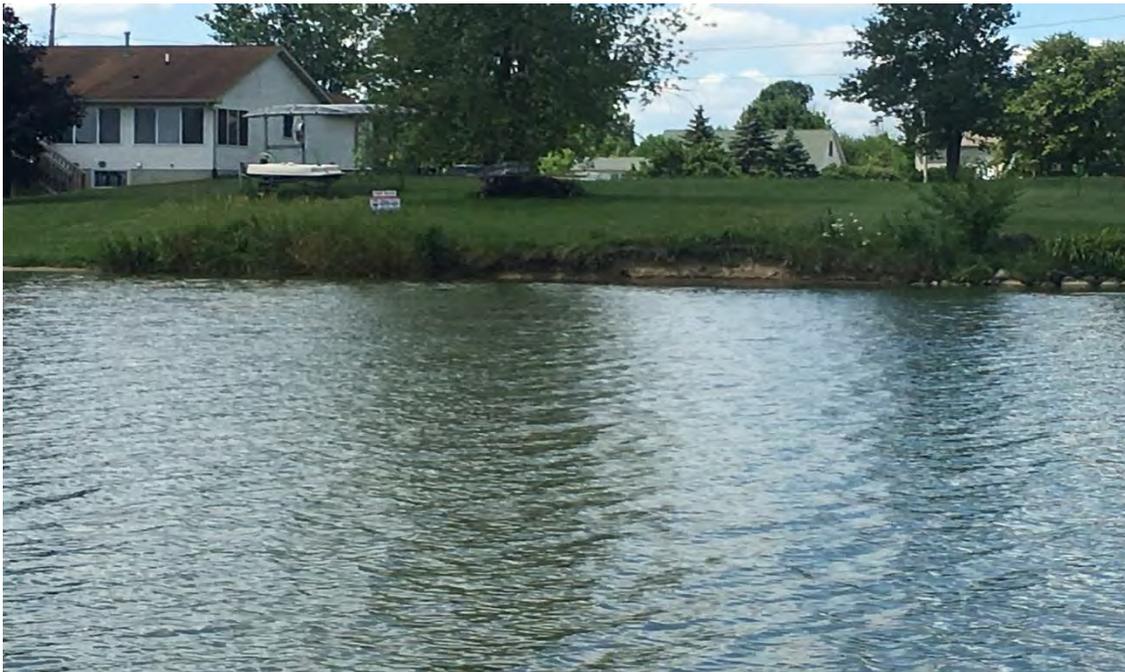
Figure 6. A photograph of a weakly stabilized shoreline on Loch Erin (RLS, 2019).

Figure 7. A photograph of a weakly stabilized shoreline on Loch Erin (RLS, 2019).

Figures 6-7 demonstrates how a shoreline without riprap or a seawall may appear with destabilized soils that can easily erode into the lake. This leads to increases turbidity of Loch Erin along with solids from the drains.

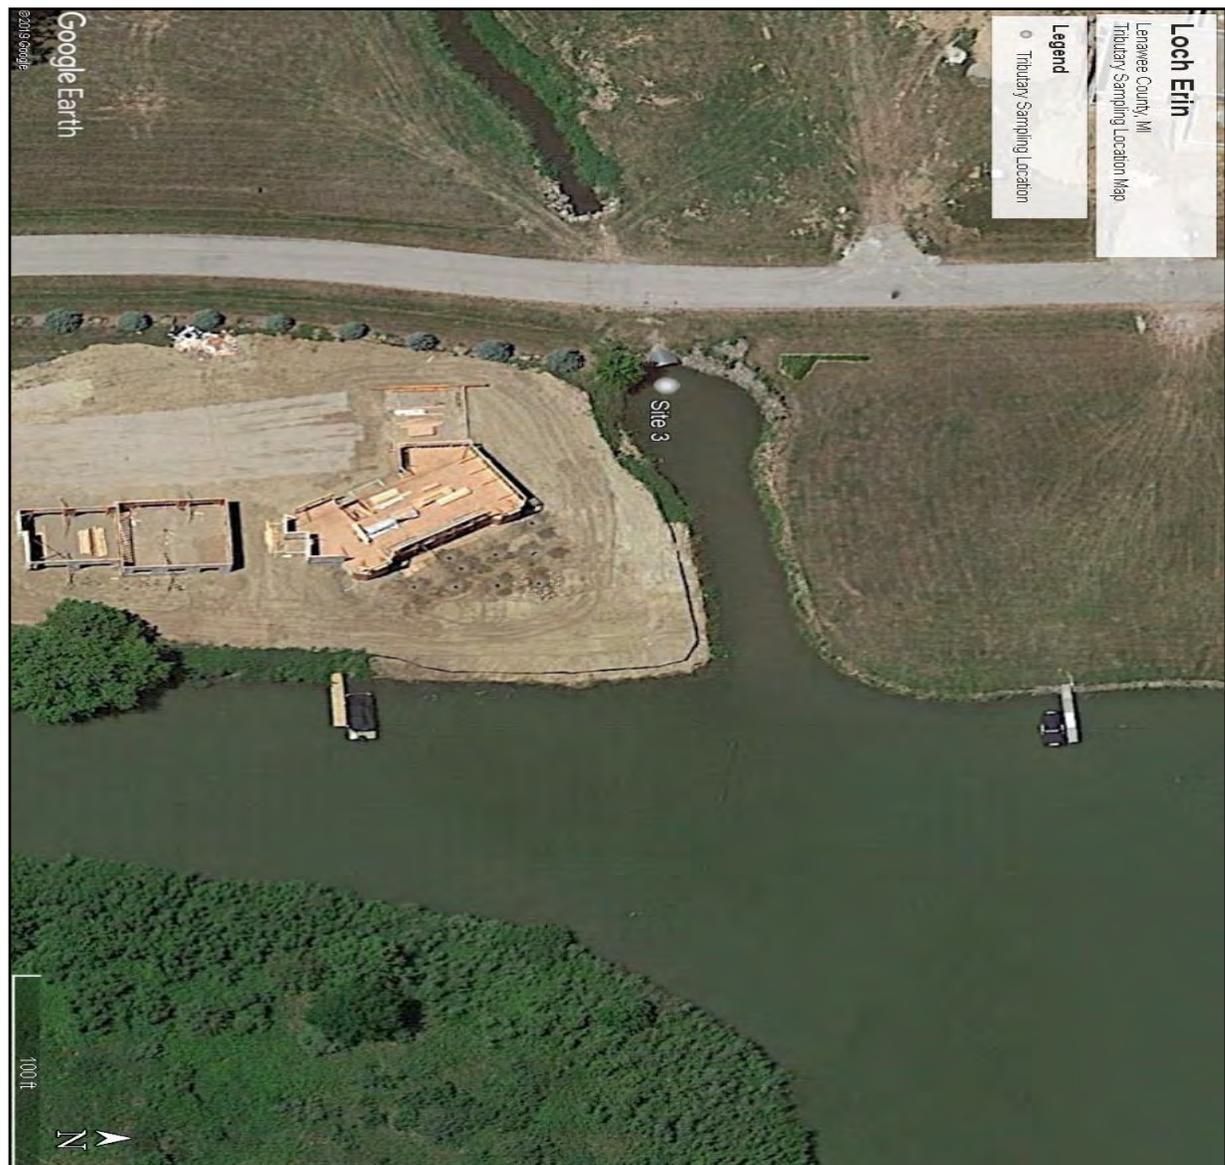
Figure 13. CSA #3 West Inlet near the west shore of Loch Erin (RLS, 2019).

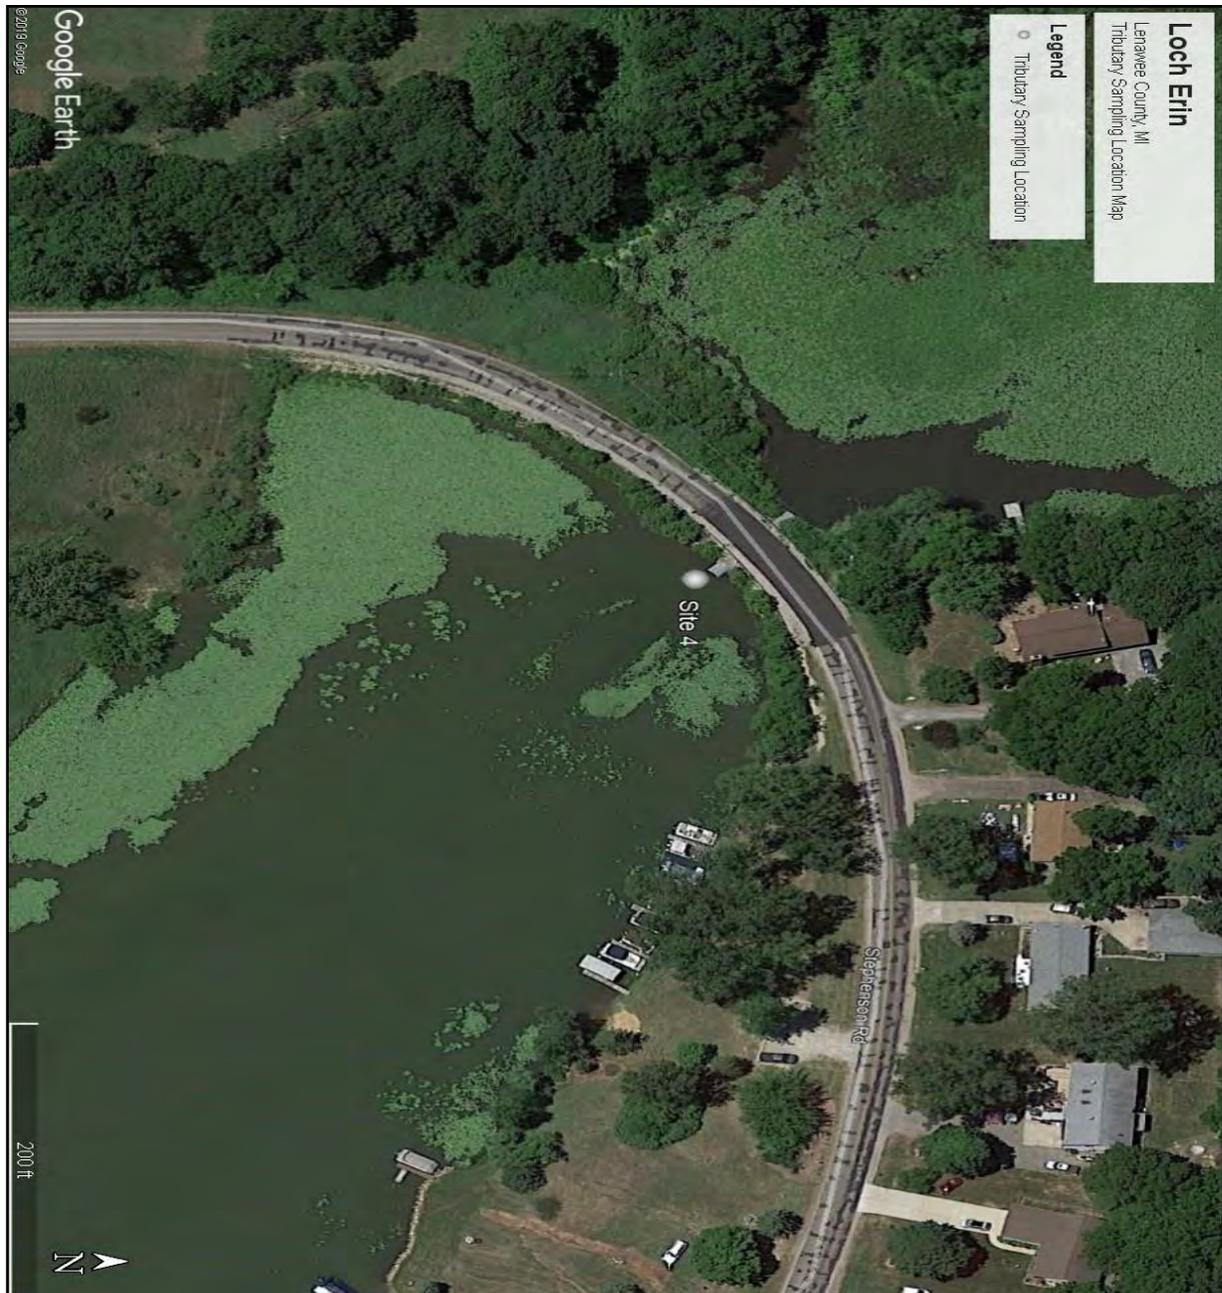
Figure 14. CSA #4 North Inlet on northwest shore of Loch Erin (RLS, 2019).

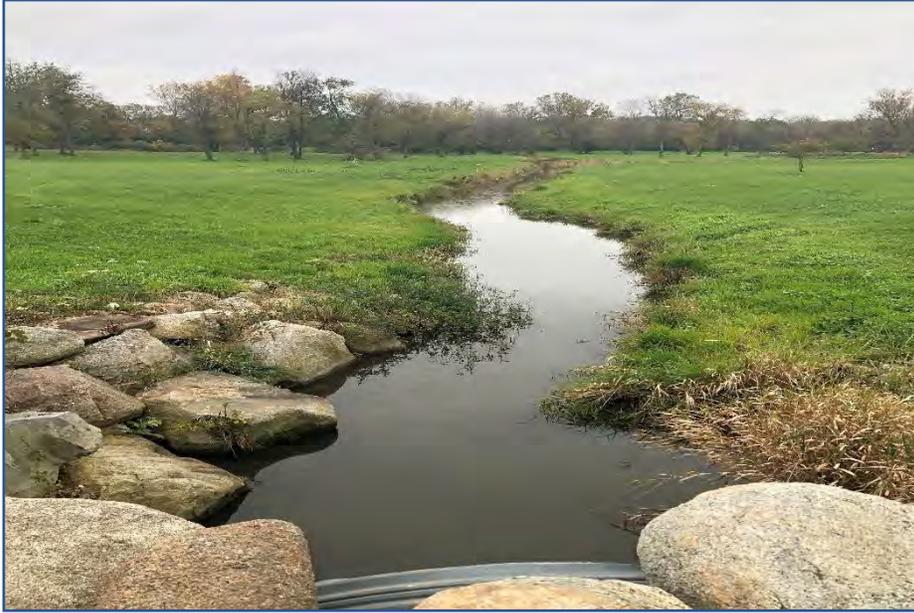
Figure 15. CSA #1 (land side).

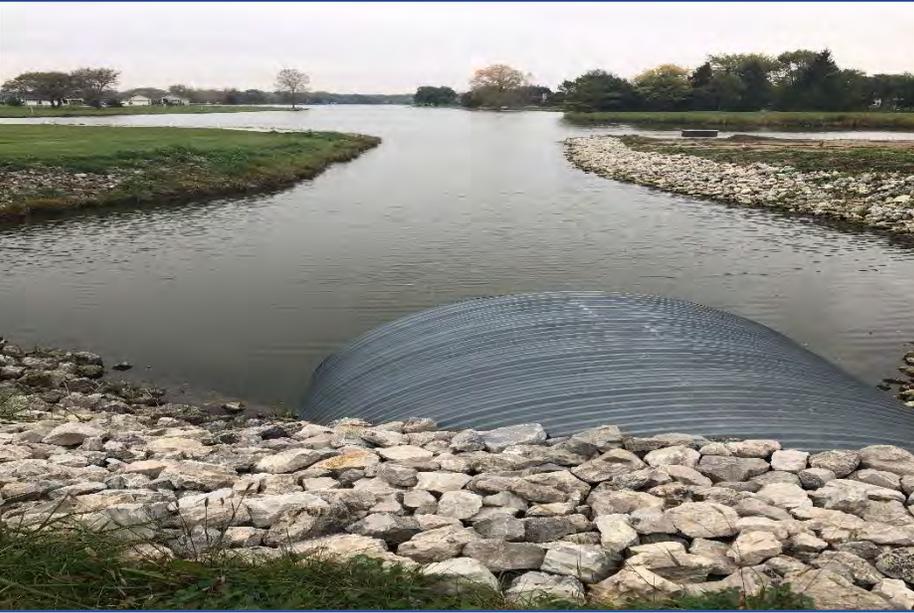
Figure 16. CSA #3 (lake side).

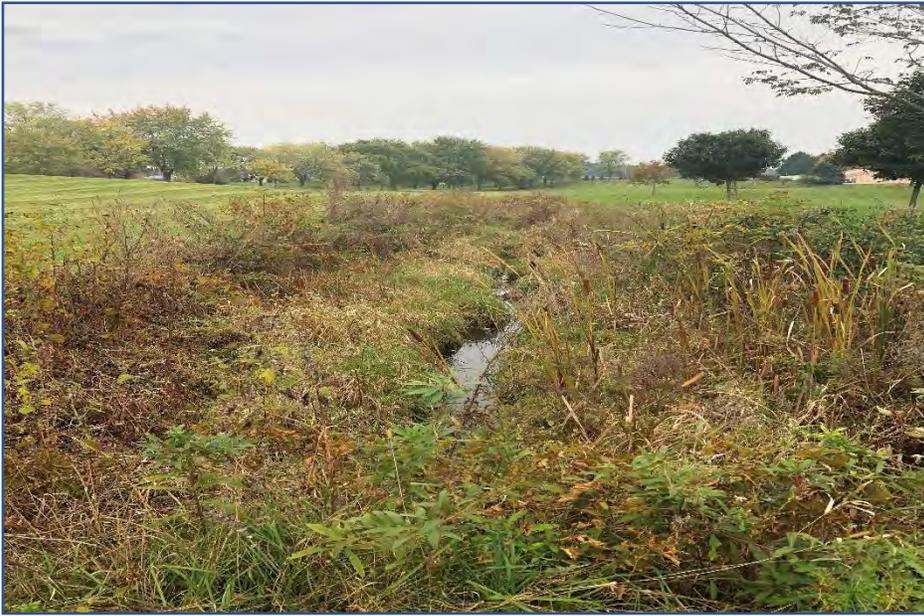
Figure 17. CSA #3 (land side).

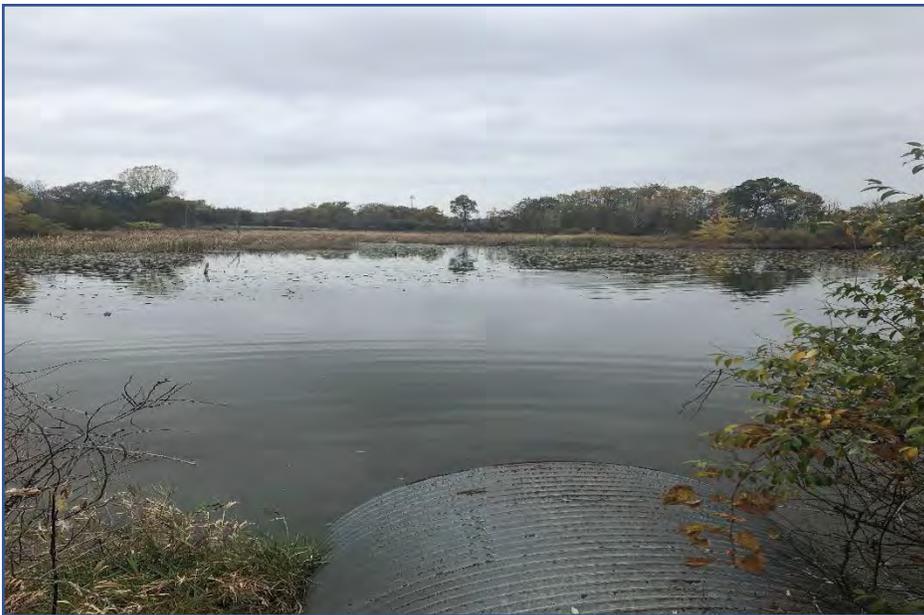
Figure 18. CSA #4 (lake side).

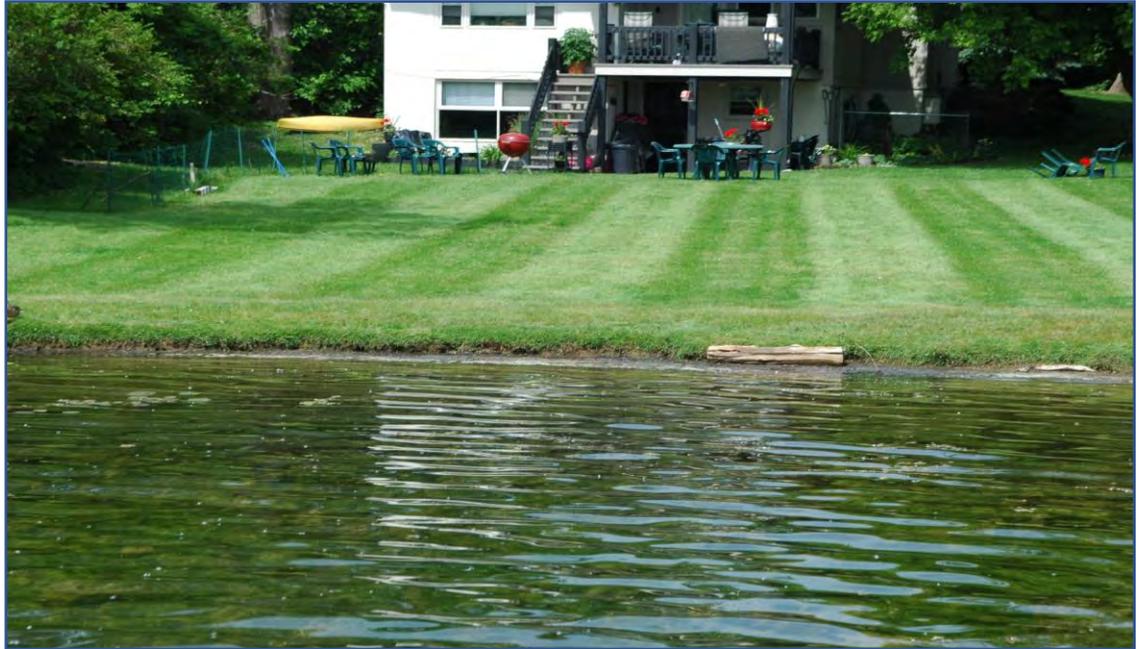
Figure 19. An example of poor shoreline management with no vegetation buffer present. ©RLS

- 7) Preserve riparian vegetation buffers around a lake (such as those that consist of Cattails, Bulrushes, and Swamp Loosestrife), since they act as a filter to catch nutrients and pollutants that occur on land and may run off into a lake. As an additional bonus, Canada geese (*Branta canadensis*) usually do not prefer lakefront lawns with dense riparian vegetation because they are concerned about the potential of hidden predators within the vegetation. Figure 19 demonstrates a lakefront property with poor management of the shoreline.

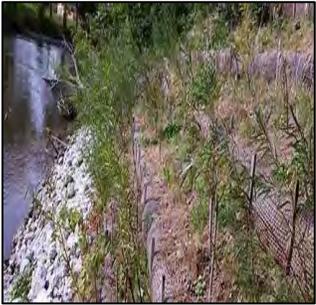
<p>Vegetative</p>	<ul style="list-style-type: none"> • Provides protection for stream banks and shorelines against erosion. • Vegetation dissipates the energy of flowing water. • Plants take-up nutrients in the soil, reducing the amount that can enter a lake. • Improves water quality in a more natural manner and maintains habitat.
<p>C. Critical Area Planting</p>

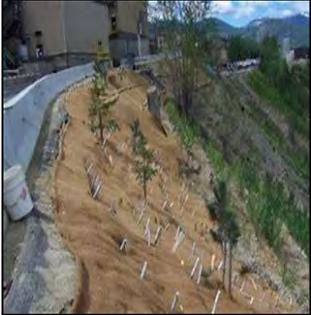
<p>Vegetative</p>	<ul style="list-style-type: none"> • Planting vegetation on highly erodible or critically eroding areas to protect water quality. • Quickly reduces the movement of soil into storm water runoff. • Plants take-up nutrients in the soil, reducing the amount that can enter a lake. • Improves water quality in a more natural manner and maintains habitat.
